DEVELOPMENT OF A FAIL SAFE DESIGN OXIDATION
RESISTANT REINFORCED CARBON SYSTEM FOR THE WING
LEADING EDGE OF A SPACE SHUTTLE VEHICLE

PHASE III FINAL REPORT
VOLUME II TECHNICAL

VSD REPORT NO. T143-5R-30008

JUNE 1973

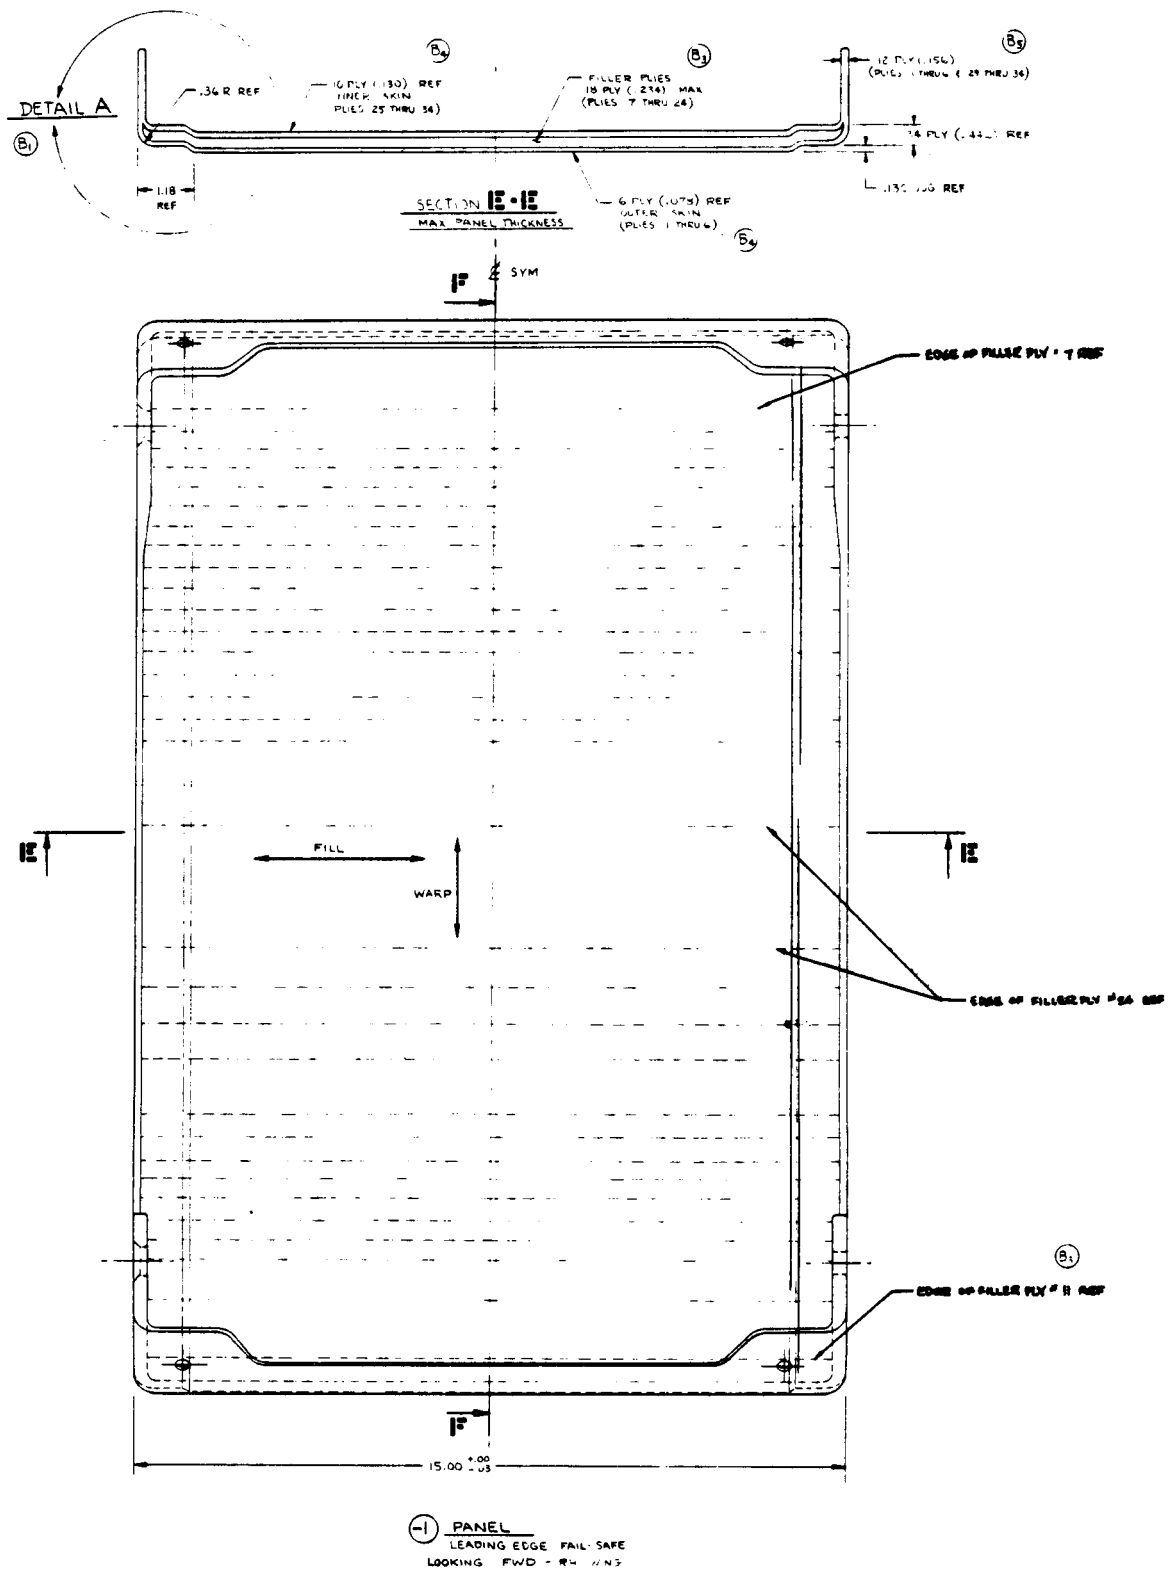
FIGURE 4 RPP PANEL ASSEMBLY — FAIL SAFE WING LEADING EDGE

RPP panel - Details of the RPP are provided in Figure 4. This drawing shows how each ply of the lay-up is to be configured and positioned. It is typical of an RPP lay-up drawing. Trim lines for each ply, where not dimensioned, are determined from a stable drawing, which is scaled by shop and inspection personnel.

The skin thickness varies from 34 plies in the stagnation area to 20 plies at the windward trailing edge and 16 plies at the leeward trailing edge. These thicknesses were selected to accommodate loss of coating, oxidation during entry with a 20 per cent margin, and sufficient remaining material to permit cruise maneuvering and landing without failure. The skin build-up is such that the oxidized condition results in continuous plies for load carrying. Thus, "filler" plies are sandwiched between continuous outer and continuous inner plies. This avoids raw edges and prevents peel.

Lug regions are built up to 23 plies as compared to the 17 plies used in Phase II. The added thickness was intended to accommodate edge radii to reduce chipping possibilities and to permit chamfer of attachment holes, while maintaining static bearing stresses low. This design shows high margins statically, but when one of the Phase III leading edges was tested under acoustic noise loading conditions, it was found that wallowing of the chamfered holes and edge chipping of the other holes occurred. Thickening the lug regions and enlarging the hole diameters proved to be an acceptable production fix as demonstrated in a retest. Lug region thickness is 34 ply (0.45 inch).

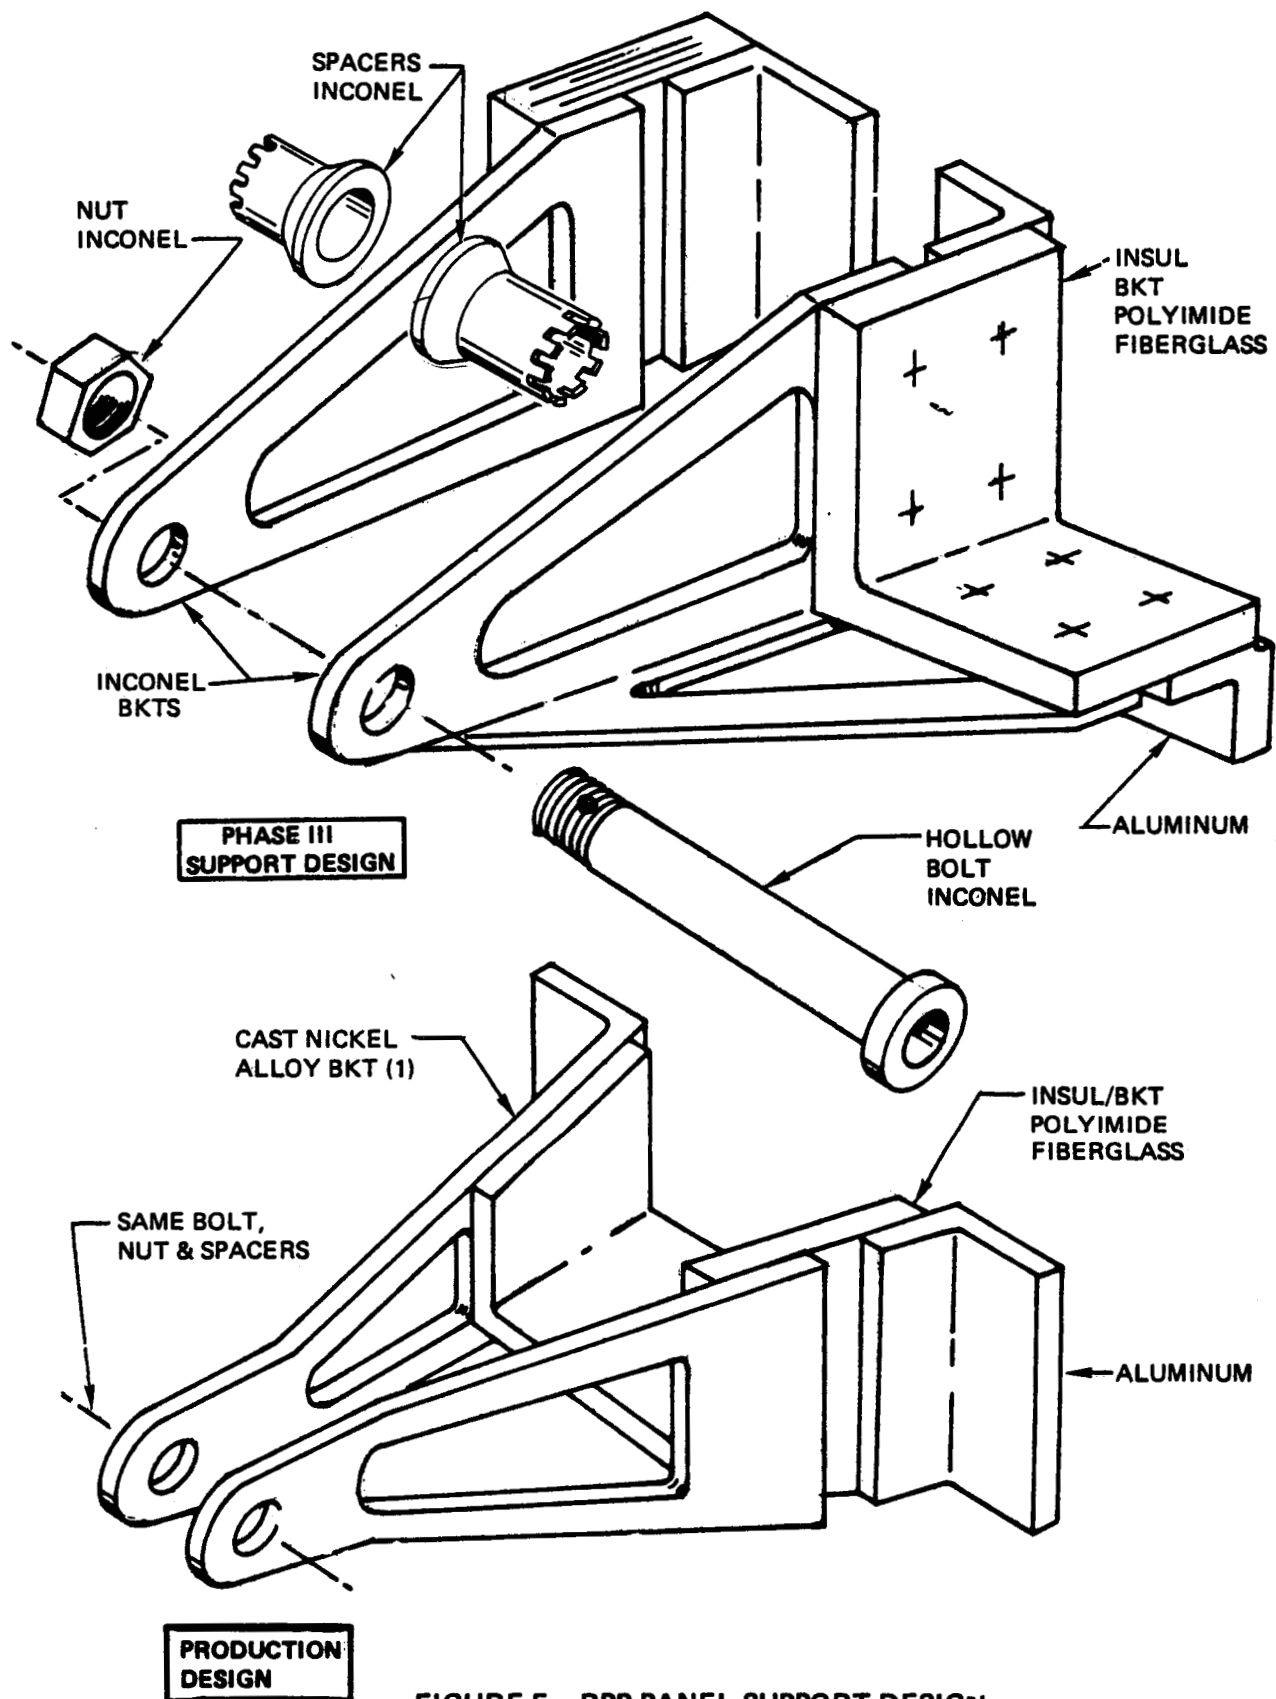
FIGURE 5 RPP PANEL SUPPORT DESIGN

The bracket design is shown in Figure 5, where the Phase III design is contrasted with a proposed production design. The primary difference between the two designs is that by virtue of the need for the Phase III test articles to be assembled as either single or dual-segment configurations, each support fitting must be a separate unit. On a flight vehicle, adjacent leading edge segments would share a single support bracket, which could be fabricated as a casting.

Because of the design of the bracket, a metal fastener and spacers are employed without the need for ceramic insulators as initially envisioned. This is a significant feature of the design, because it eliminates potentially unreliable, brittle ceramic insulators. Results from the acoustic noise test (reference Section 1.1.1.4) strengthen this contention, where even the coated RPP suffered wear and chipping. It doesn't appear feasible to employ ceramics unless these are close fitting and trapped or encased so that in the event fracture is encountered, pieces are not lost.

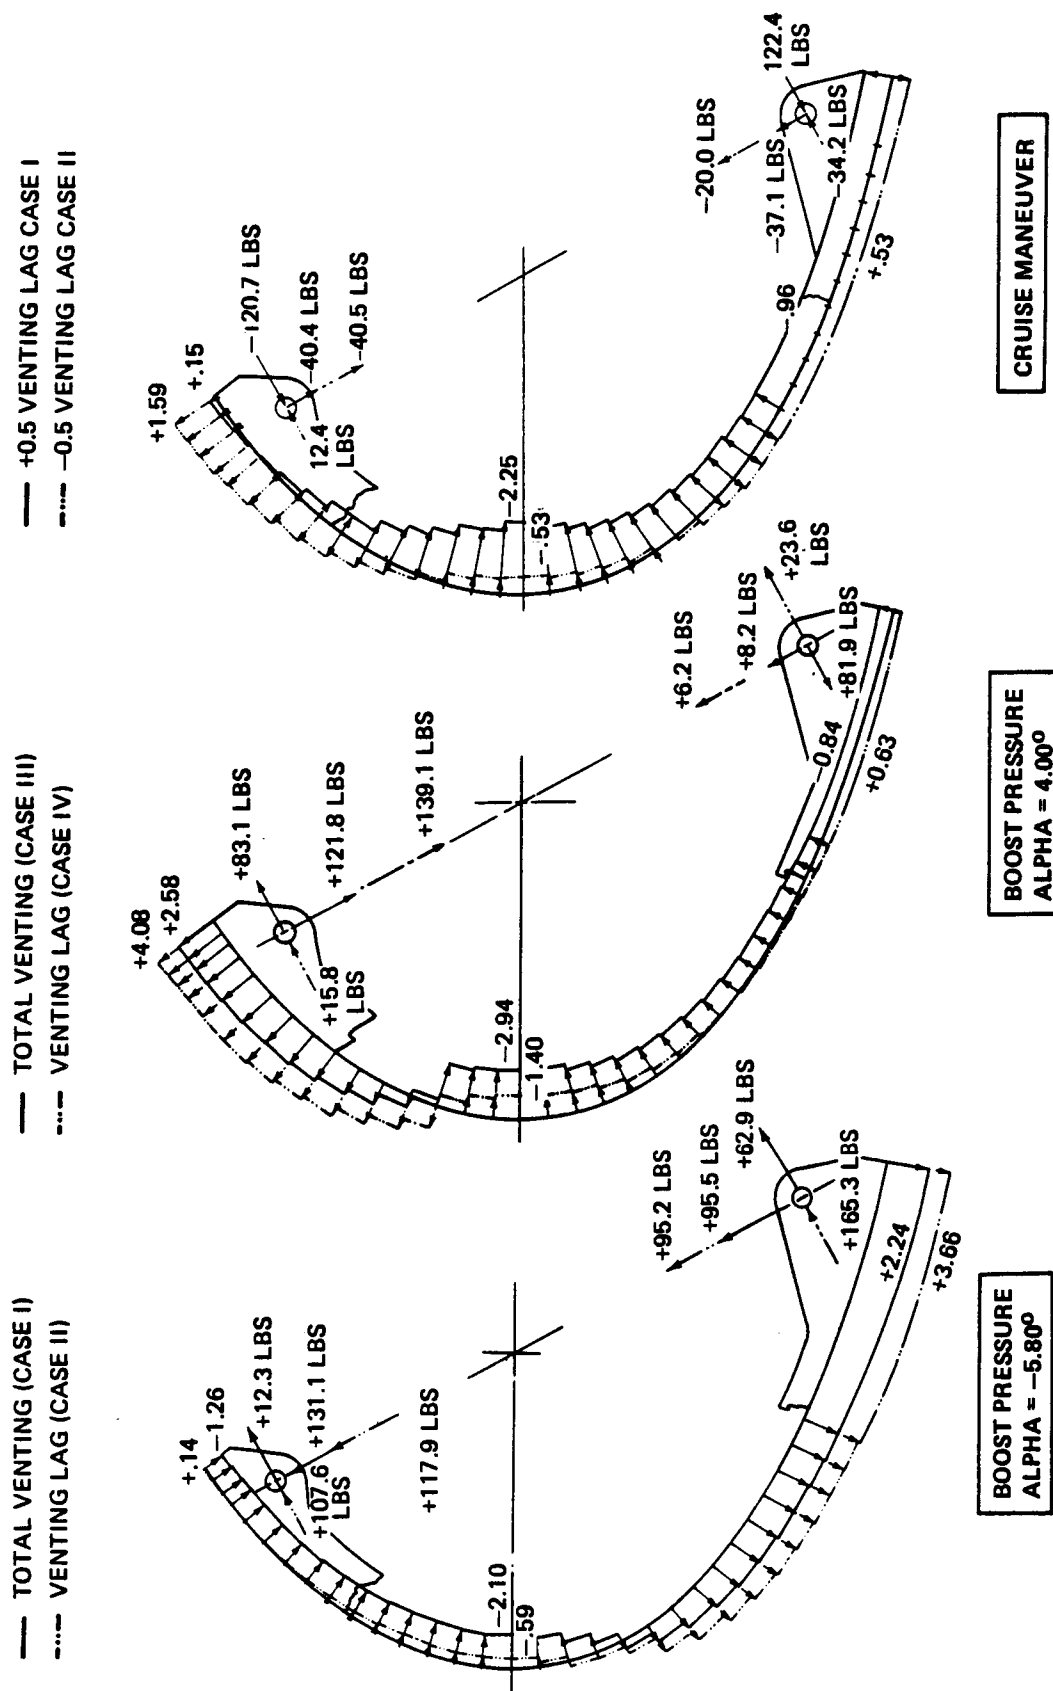
FIGURE 7 ULTIMATE DESIGN LOADS

Load Case I, Figure 7, Cruise Maneuver, is the critical cruise load for buckling. This load condition occurs during a 2.5 g maneuver and includes an 0.5 psi collapse venting lag.

Support Structure - The titanium support structure and support brackets were analyzed for the leading edge reactions from the loading conditions defined in Figure 7, the 32 g-rms limit side load condition, and for the entry condition, where the front truss member expands relative to that portion tied to the wing spar. A summary of margins is given in Figure 16.

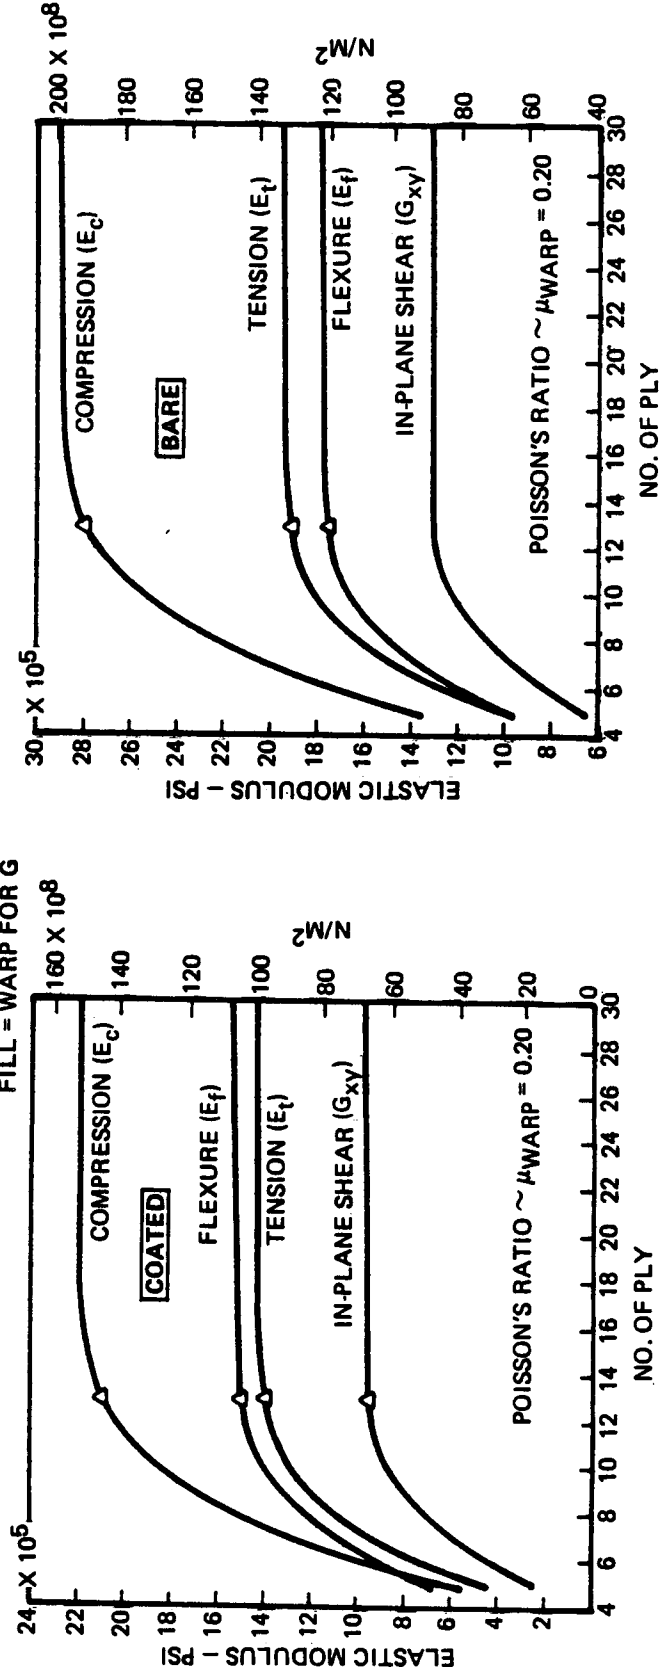
FIGURE 8 DESIGN PROPERTIES USED — RPP BARE AND COATED, ROOM TEMPERATURE, WARP DIRECTION

RPP Design Allowables - Structural analysis of the leading edge requires material allowables for both coated and bare RPP. Bare data is employed in analysis of the "oxidized" leading edge for cruise maneuver loads while coated data is used for all other design conditions. Since test data covering the full range of design thicknesses were not available at the time of design analysis, extrapolation of the then existing data was required to establish design allowables. Room temperature strength and elastic moduli used for analysis are shown in Figure 8. These were established from data of reference 2 and in-house tests. Strength properties show a 33% reduction from average values based on a statistical evaluation of 57 flex bars from 17 coating runs as summarized in reference 2. This produced "A" values, 99% probability, 95% confidence, approximately 33% below average values. This relationship was also applied to all other strength properties in lieu of specific statistical data.

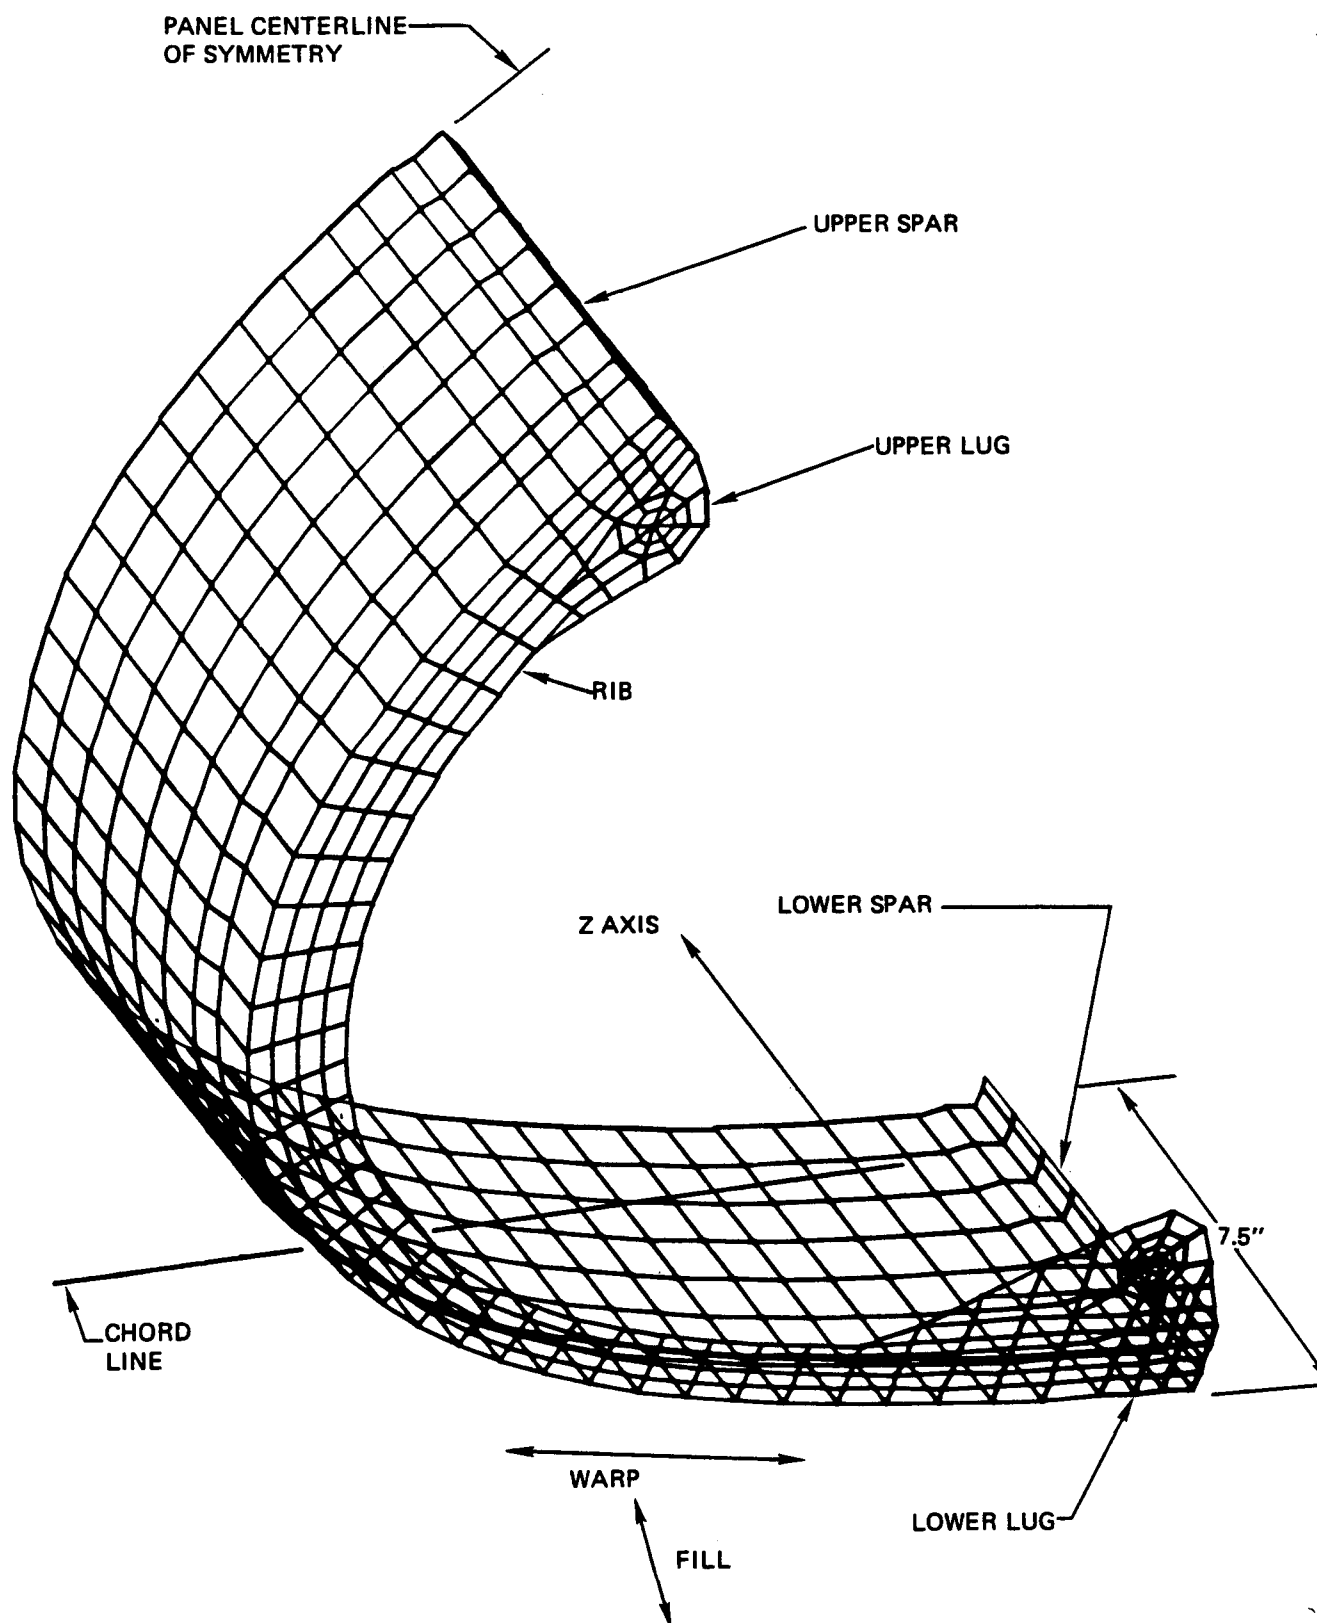
FIGURE 10 PERSPECTIVE OF NASTRAN LEADING EDGE MODEL

Boost Loads Analysis - All structural analyses conducted on the Phase III leading edge used NASTRAN, level 11.1.4, which is a finite element computer analysis technique, employing bending and membrane elements. Because of symmetry in both loads and design only one-half of the leading edge was modeled for boost pressure loads analysis. The model, which included 3000 degrees-of-freedom, is pictured in Figure 10. This same grid pattern was also used for thermoelastic analyses and was coincident with the thermal model to avoid temperature interpolation. A summary of the critical stress conditions and margins of safety is given in Figure 11. The minimum margin for pressure loads (excluding the side load case) is 40% which occurs in the rib flange. All other margins are high, being over 100%.

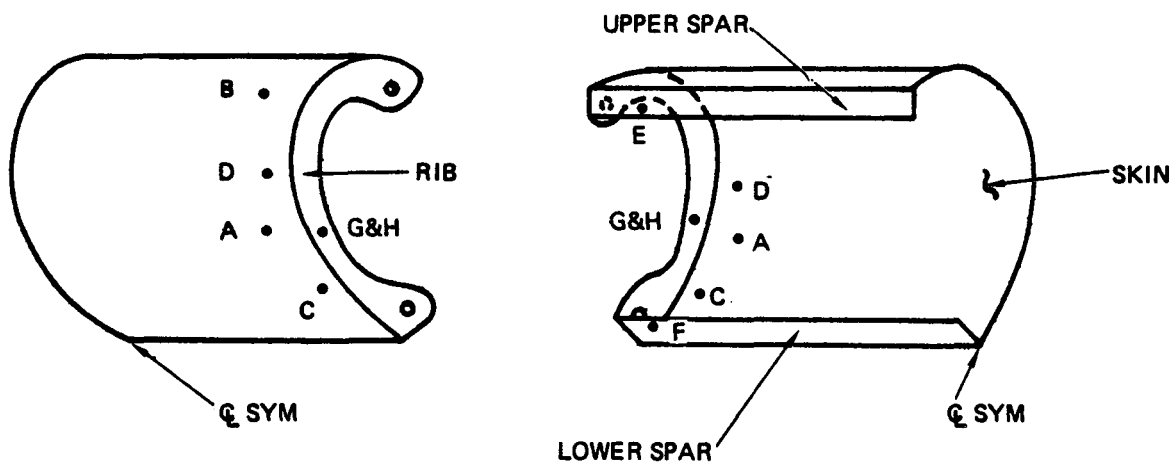
POSITION	STRUCTURE	MATERIAL THICKNESS & TEMPERATURE	TYPE OF STRESS	MAXIMUM ULTIMATE STRESS PSI	ALLOW.* STRESS PSI	ULT. MARGINS OF SAFETY	SEC. FROM ENTRY
A	SKIN	29 PLY 1960°F	TENSION	1790	6,300	+2.52	400
B	SKIN	34 PLY 2420°F	FLEXURE	1050	15,250	HIGH	400
C	SKIN JOGGLE	25 PLY 1560°F	COMPRESSION	-2900	-10,400	+2.59	400
D	SKIN	29 PLY 1560°F	SHEAR	1070	2,500	+1.34	400
E	UPPER SPAR	20 PLY 805°F	TENSION	1400	5,600	+3.00	400
F	LOWER SPAR	20 PLY 920°F	COMPRESSION	-1000	-9,000	HIGH	260
G	RIB	12 PLY 1410°F	TENSION	2050	5,600	+1.74	300
H	RIB	12 PLY 2180°F	COMPRESSION	-1560	-12,000	HIGH	400
J	SKIN	16 PLY 670°F	TENSION	1030	3,600	+2.5	400
*FROM FIGURE 8 AND 9

A summary of the margins of safety computed for the entry thermal conditions are shown in Figure 12. All margins are large with the minimum being 134% at ultimate. This results from circumferential skin gradients at 400 seconds, when temperatures are maximum. The next lowest margin is 174% on tension and occurs in the ribs due to thermal gradients through the rib flange depth.

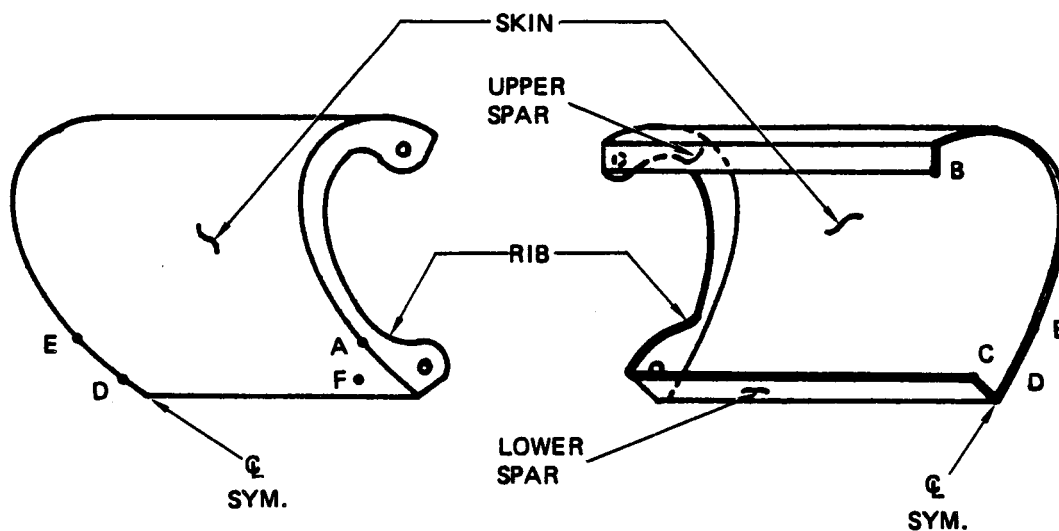
LOCATION	STRUCTURE	TYPE OF STRESS	MAX. ULTIMATE STRESS PSI	ALLOW.* STRESS PSI	LOAD CASE	MARGIN OF SAFETY
A	RIB	TENSION	540	5400	1	HIGH
B	UPPER SPAR	COMPRESSION	-950	-8700	2	HIGH
C	LOWER SPAR	TENSION	1190	6100	1	4.13
D	SKIN	TENSION	581	6700	1	HIGH
E	SKIN	FLEXURE + AXIAL	-840	11000	1	HIGH
F	SKIN	SHEAR	960	2400	1	1.50

**FIGURE 13 SUMMARY OF MARGINS OF SAFETY
OXIDIZED LEADING EDGE – CRUISE MANEUVER**

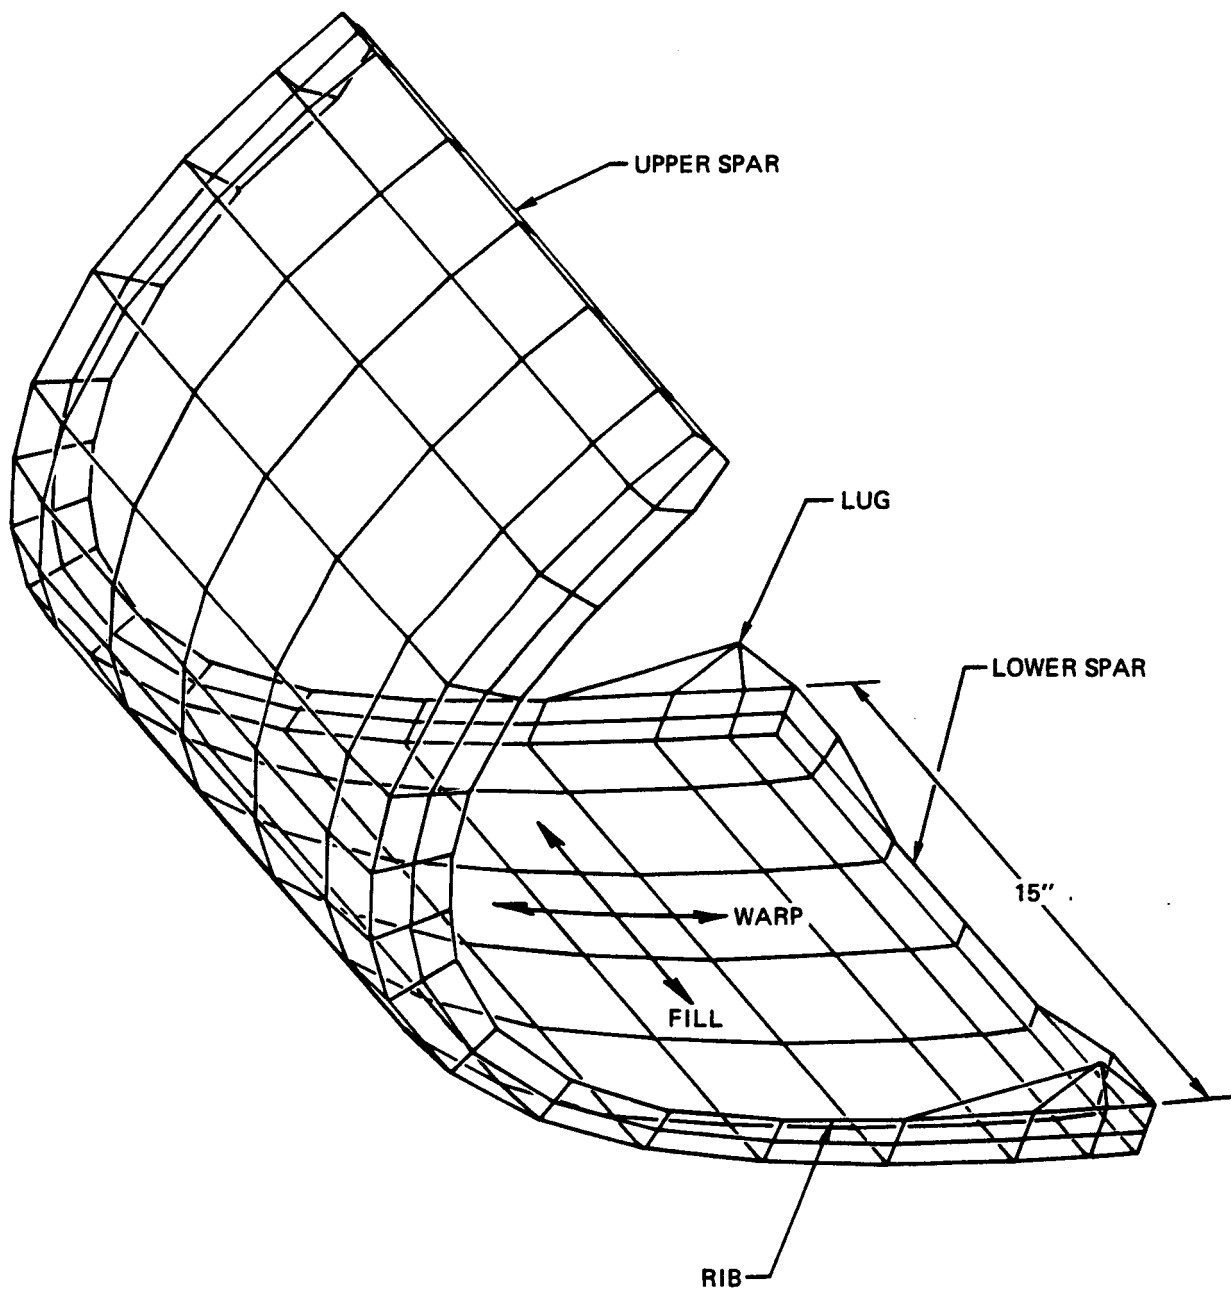
FIGURE 14 LEADING EDGE NASTRAN BUCKLING MODEL

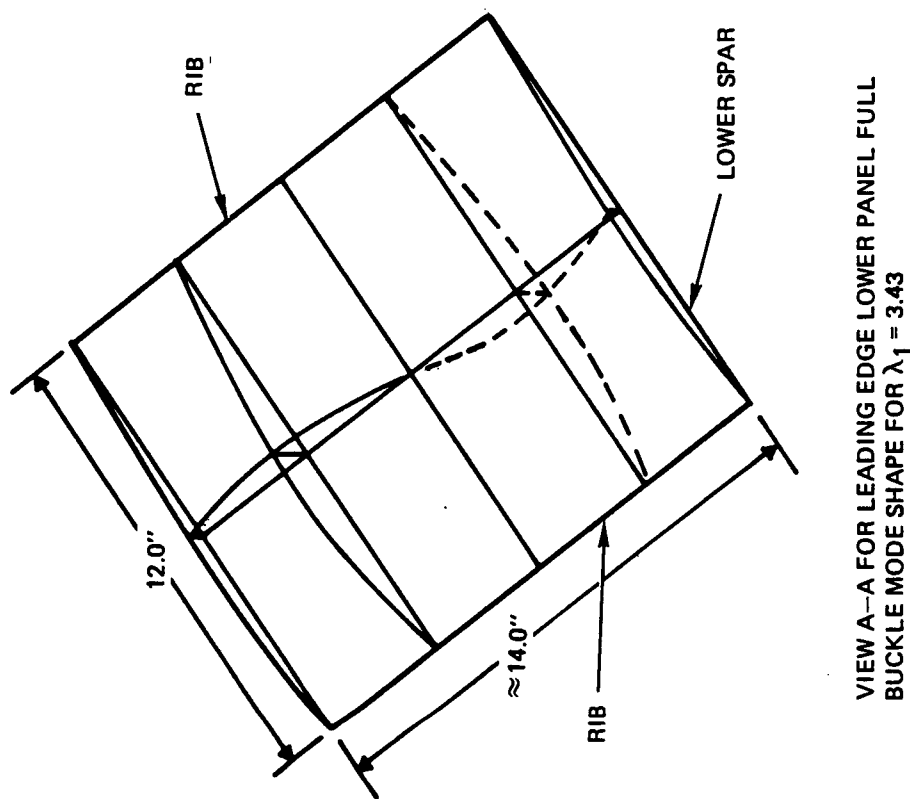
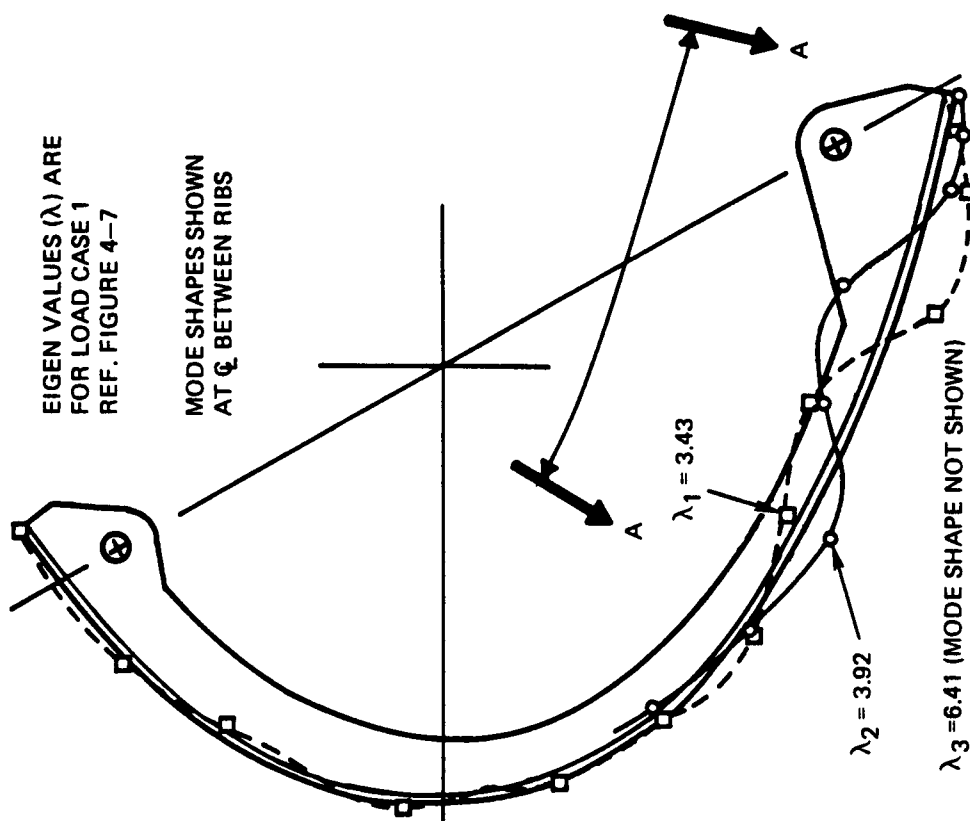
FIGURE 15 BUCKLE MODE SHAPES

A classical buckling problem was evaluated using NASTRAN and the results compared favorably. A simply supported 6" x 12" flat aluminum sheet loaded in edgewise compression was evaluated using NASTRAN and found to have a minimum eigenvalue of 0.976 and a full sine buckle mode shape. Classical theory predicts an eigenvalue of 1.05 and a full sine buckle mode shape.

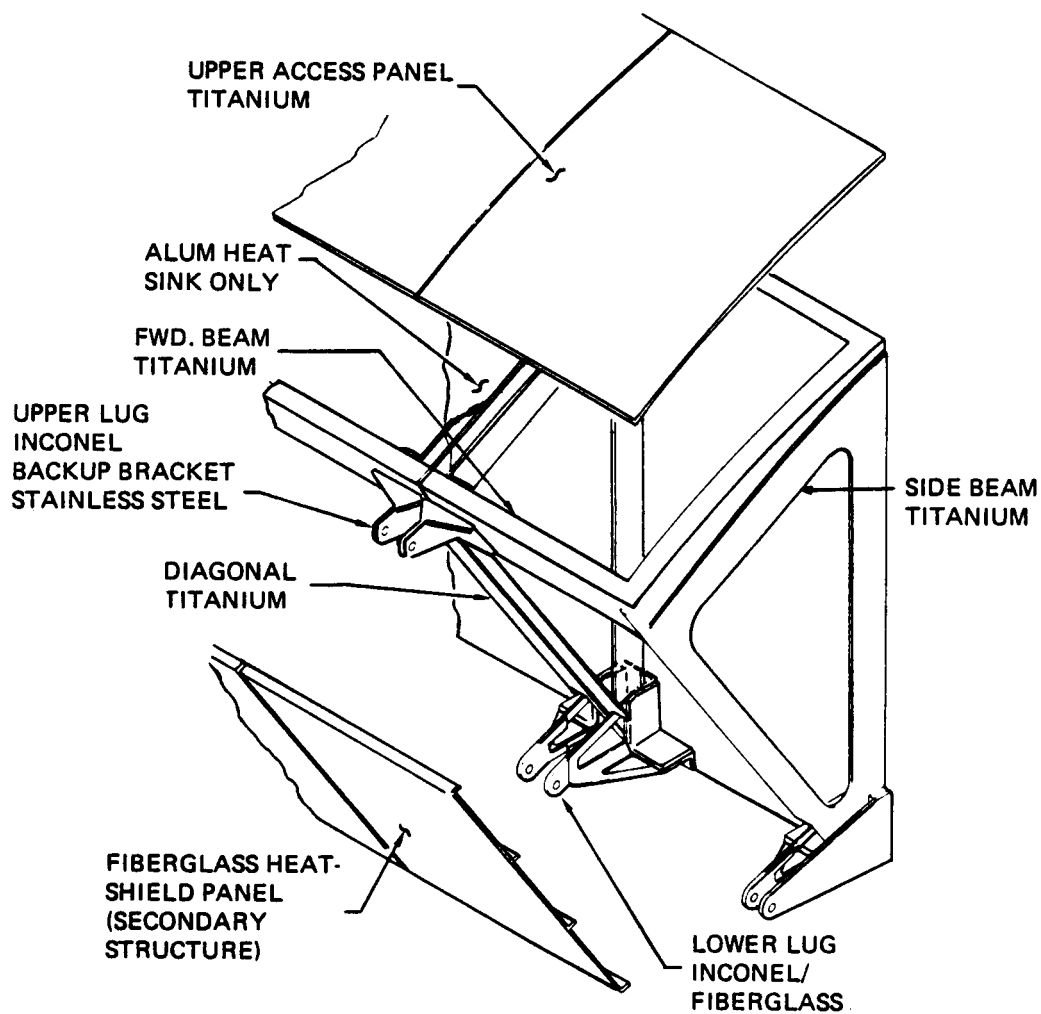
ITEM	MATERIAL	CRITICAL CONDITION	ULTIMATE MARGIN OF SAFETY	MODE
UPPER ACCESS PANEL	.064 6AL-4V T1	BOOST	+1.81	BUCKLING
RIB TRUSE				
- FWD BEAM	.064-.072 6AL-4V T1	BOOST	+0.79	CRIPPLING
- SIDE BEAM	.04-.072 6AL-4V T1	BOOST	+1.00	CRIPPLING
- DIAGONAL	.04 6AL-4V T1	BOOST	+1.31	CRIPPLING
		ENTRY-THERMAL EXPANSION	+0.19	CRIPPLING
- VERTICAL	.04 6AL-4V T1	ENTRY-THERMAL EXPANSION	+1.90	CRIPPLING
UPPER LUG	.156 INCONEL 718	SIDE LOAD VIBRATION	+1.21	BENDING
BACK-UP BRACKET	.156 321 STAINLESS STEEL	SIDE LOAD VIBRATION	+0.66	BENDING
LOWER LUG	.078 INCONEL 718	SIDE LOAD VIBRATION	+0.51	CRIPPLING
- SPLICE	.25 POLYIMIDE	SIDE LOAD VIBRATION	HIGH	COMPRESSION
- ATTACH ANGLES	.125 2024-T4 ALUM	SIDE LOAD	+0.83	BENDING
LUG BOLT	INCONEL 718	BOOST ENTRY	HIGH HIGH	BENDING BENDING

The lowest margin, 19%, is somewhat fictitious, since this is based on crippling. For the thermal expansion condition the crippled flange will simply "get out of the way" and the remaining members will continue to support the induced loads. Other margins are considerably in excess of the 0% margin required.

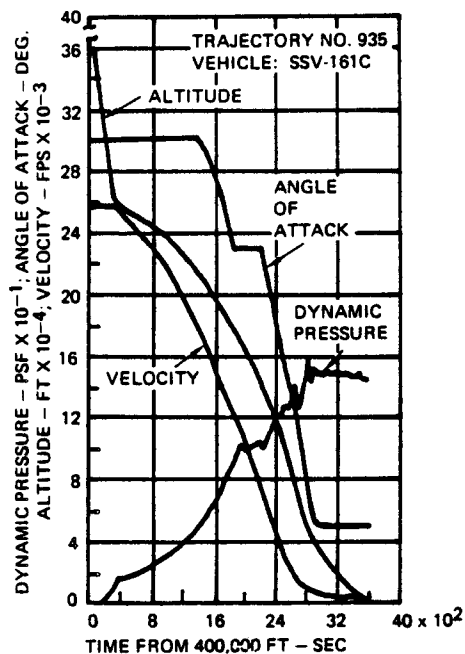
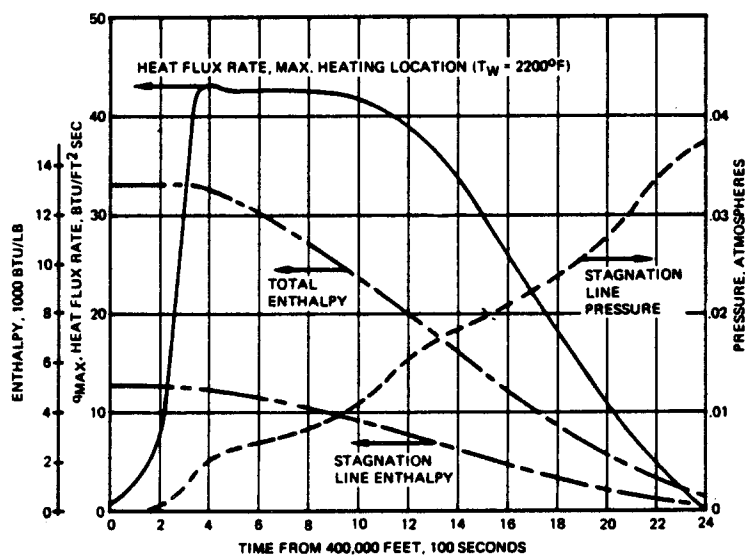
FIGURE 17 ENTRY DESIGN TRAJECTORY

Design Criteria - Thermal design criteria were the same as those employed in the Phase II program, reference (2). Only the entry trajectory is critical for thermal and thermal stress conditions. The design entry profile is given in Figure 17. No specific factors of safety were employed on heating rates or temperatures. Heating rate distribution around the leading edge, used for design, is provided in Figure 18. These data are for the Rockwell International delta winged vehicle SSV-161C, and the entry data is for trajectory No. 935.

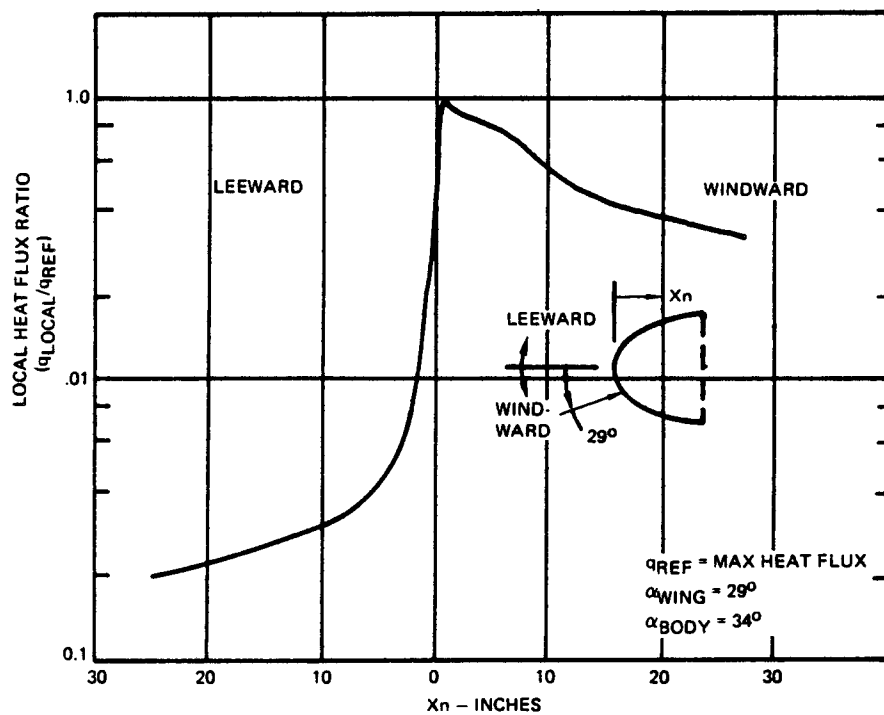
FIGURE 18 HEATING RATE DISTRIBUTION AROUND LEADING EDGE

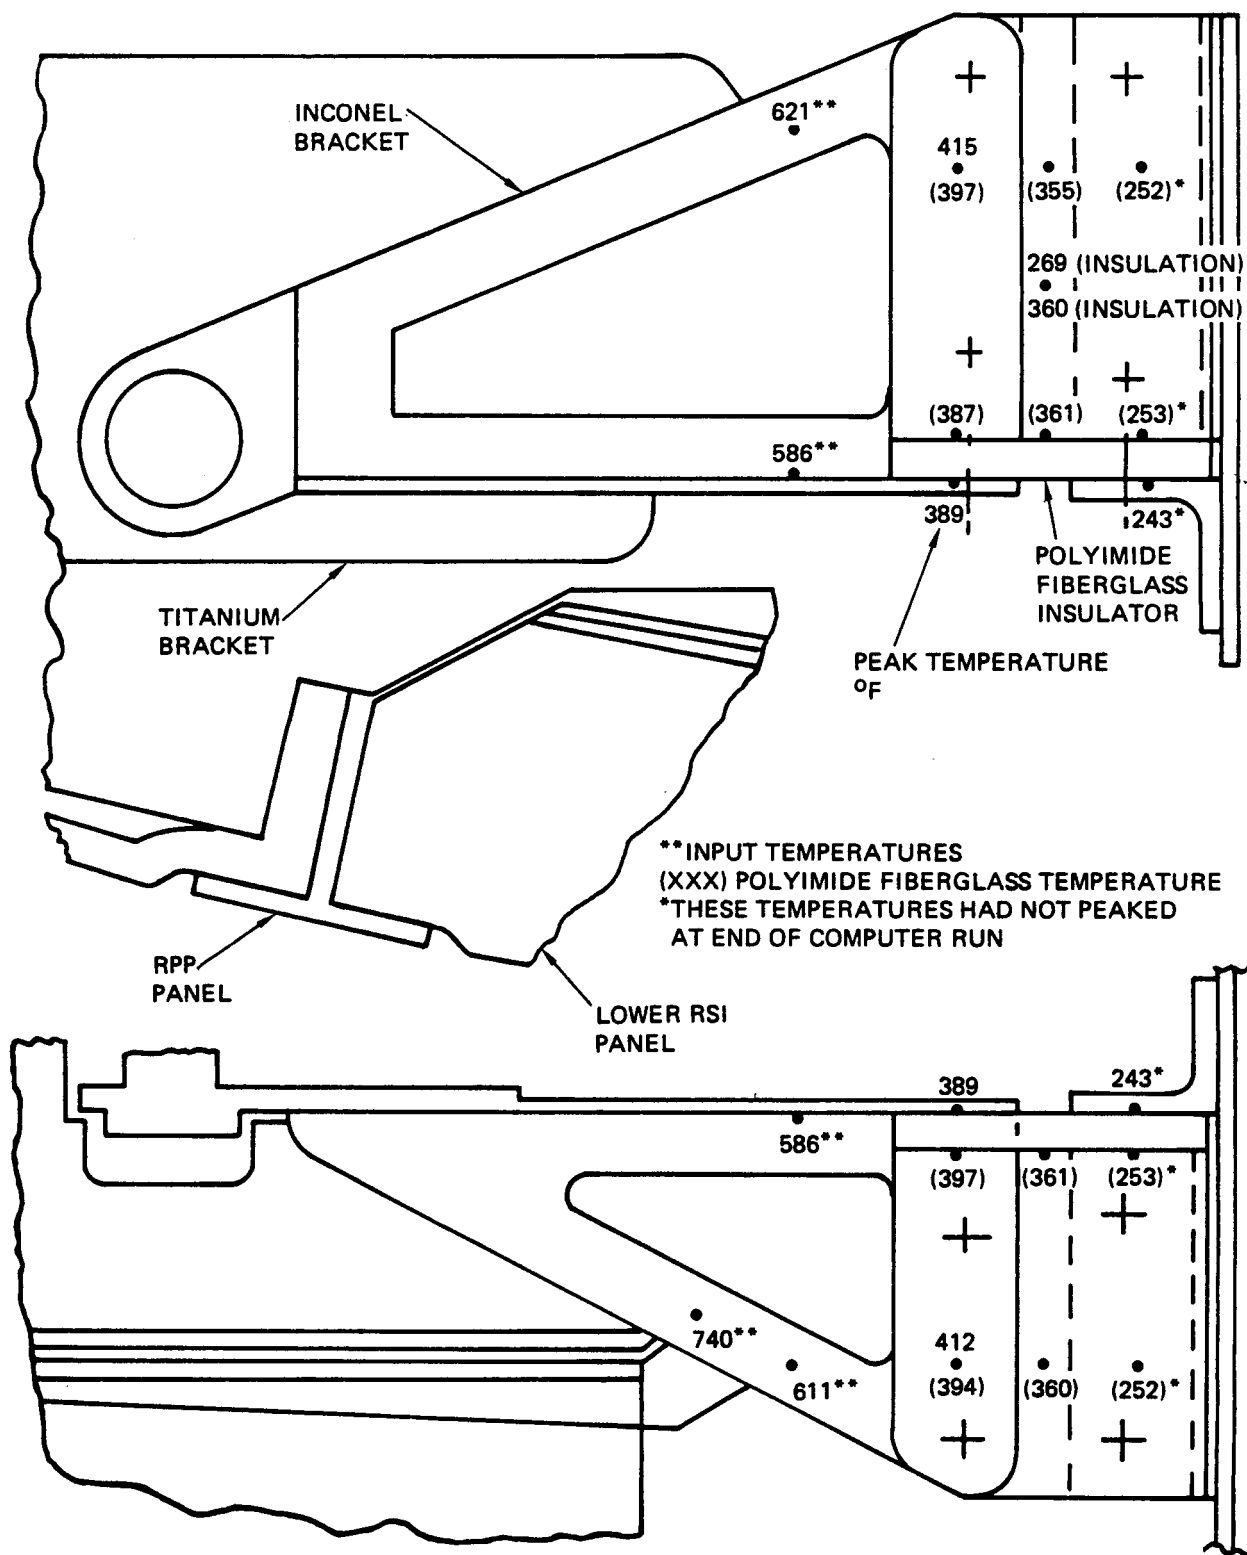
FIGURE 30 PEAK TEMPERATURES IN LOWER LUG SUPPORT

Peak computed temperatures for the final configuration are presented in Figures 28, 29, and 30. Maximum temperature of the polyimide insulator in Figure 30 is 397°F, which is well within tolerance limits. The aluminum substructure temperature had not peaked at the end of the computer run at 5300 seconds. However, the temperature rise of the aluminum at this time was only 113°F as compared to a temperature rise

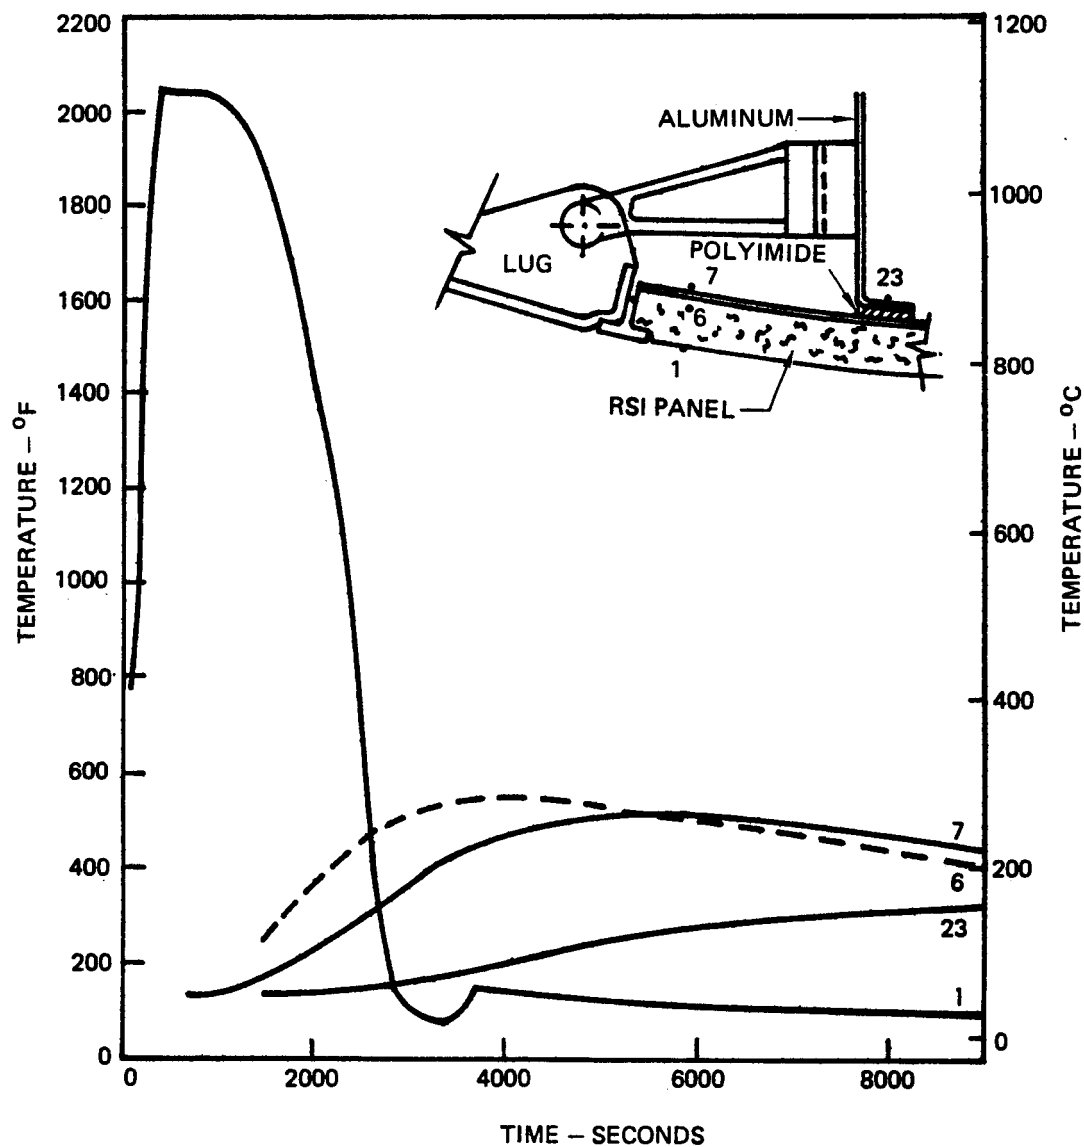
FIGURE 33 PREDICTED TEMPERATURES WINDWARD SIDE RSI PANEL

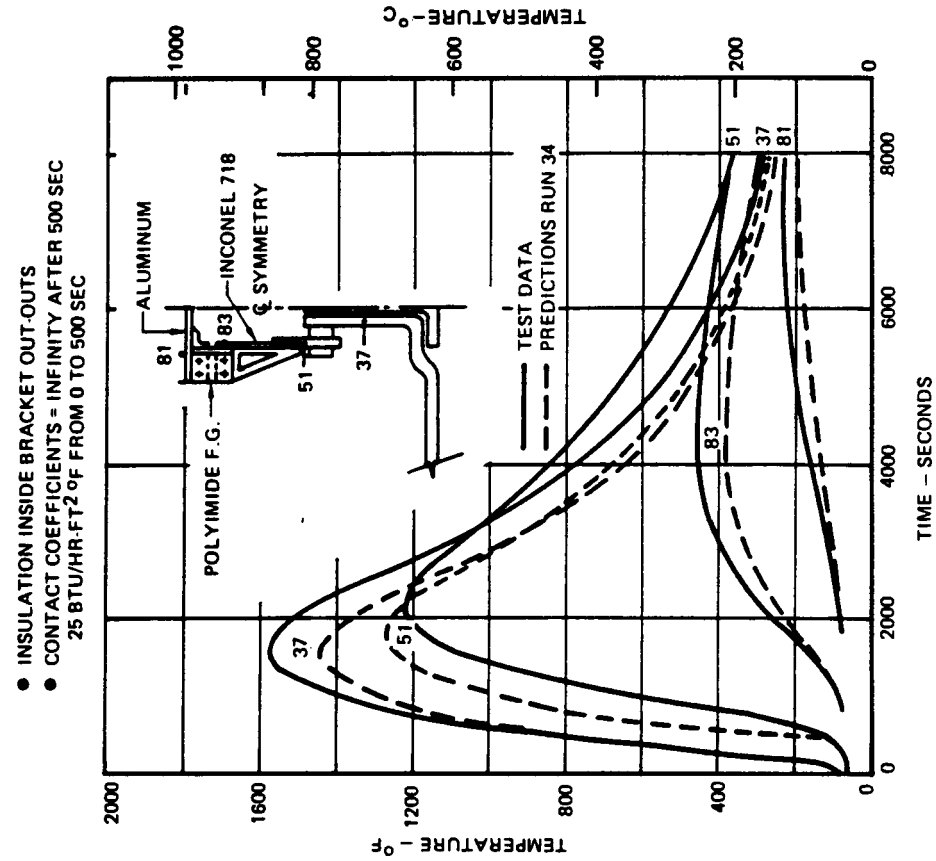
FIGURE 34 RPP LUG TEST FINAL PREDICTIONS VS TEST DATA

A summary of analysis and test data for the lower support bracket is given in Figures 34 and 35. Final analytical predictions using a
